# PRODUCT SPECIFICATION RESOURCE

Contains specifications and test reports for  
ConduDisc Elite manufactured by SAE Inc.

## Resistance to Electrolytic Corrosion Comparison: Blackburn GP-100 Copper Grounding Plate, a Galvanized Steel Grounding Plate and the ConduDisc

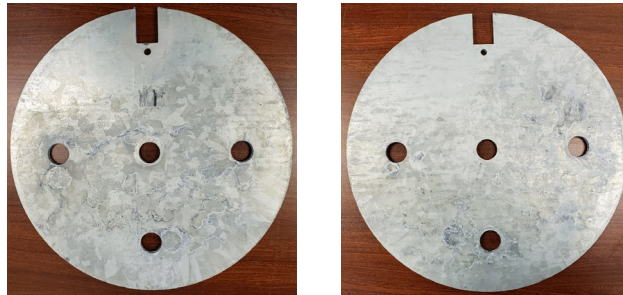
Figure 4: Galvanized Steel Grounding Plate, Prior to the Experiment

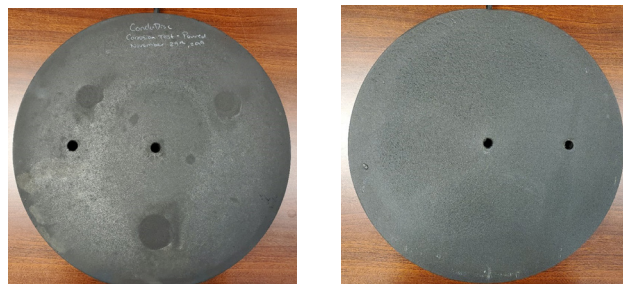
Figure 6: ConduDisc, Prior to the Experiment

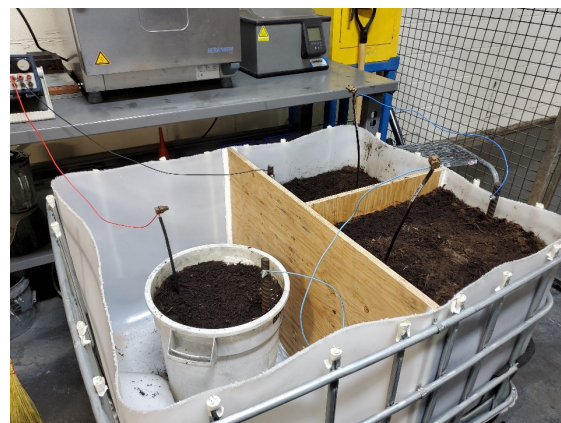
Figure 7: Test Setup

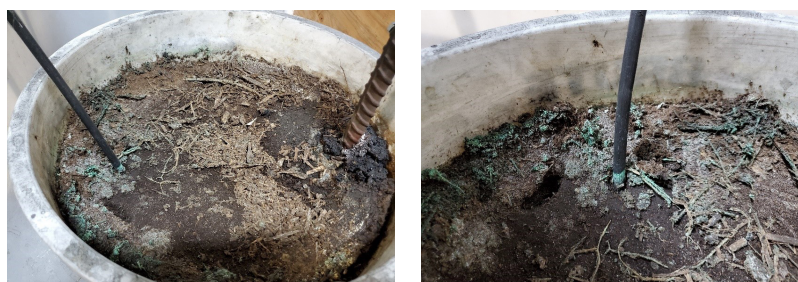
Figure 10: Copper Salt Visible on Top of the Soil in the Blackburn GP-100 Copper Grounding Plate Pail at the Completion of the Experiment

- 3.2 After one year the experiment was completed and the samples were removed from the soil for analysis. The samples were cleaned and weighed using an electronic balance. As shown in Table 2 and Figures 10, 11, and 12 the Blackburn GP-100 Copper Grounding Plate experienced significant corrosion during the course of the experiment and only 25.6% of the grounding plate remained after being exposed to 10 mA for one year. Additionally shown in Table 2 and Figure 13 the galvanized steel grounding plate corroded during the course of the experiment, losing 1.25% of its mass after being exposed to 10 mA for one year and visibly oxidizing on over half of the exposed surface. In contrast, as shown in Table 2 and Figures 14 and 15, the galvanized steel plate encased in ConduDisc surround material did not visibly oxidize and experienced no change in mass after being exposed to 10 mA for one year. The small gain in mass can be attributed to the small amount of ConduDisc surround material that could not be removed from the galvanized steel plate prior to weighing.

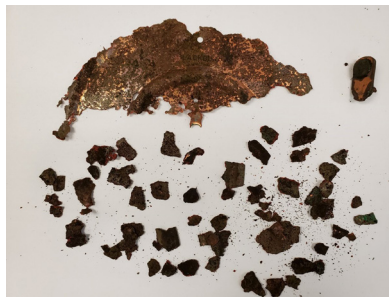
Figure 12: Blackburn GP-100 Copper Grounding Plate with Corroded Pieces Remaining in Soil, After Experiment

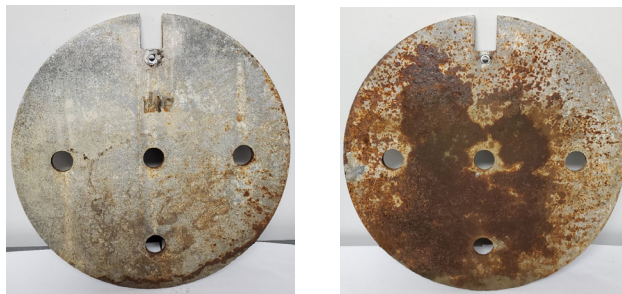
Figure 13: Galvanized Steel Grounding Plate, After Experiment

The Galvanized Steel Grounding Plate experienced a loss in mass of 1.25% during the one year study. Additionally, there was a large amount of visible oxidation of the surface of the Galvanized Steel Grounding Plate, the zinc coating on approximately half of the exposed surface had corroded.

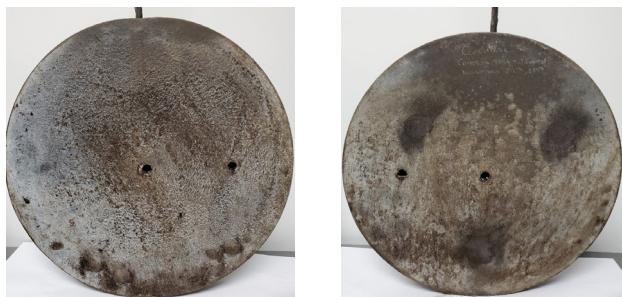
Figure 14: ConduDisc, After Experiment

In comparison, the ConduDisc, a galvanized steel plate encased in a conductive polymeric surround, experienced no loss of mass during the one-year study. The low permeability of the ConduDisc surround material protected the encased galvanized steel plate from exposure to the moisture and salt in the soil, thus preventing any corrosion from occurring.

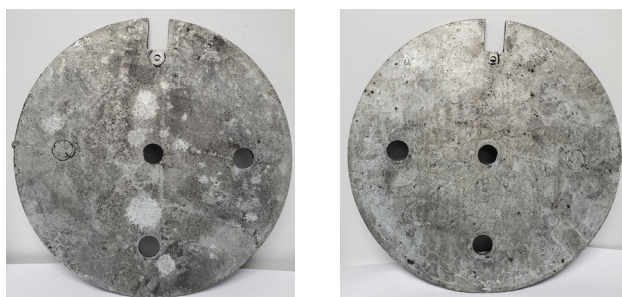
Figure 15: Galvanized Steel Plate that was Encased in ConduDisc Surround, After Experiment

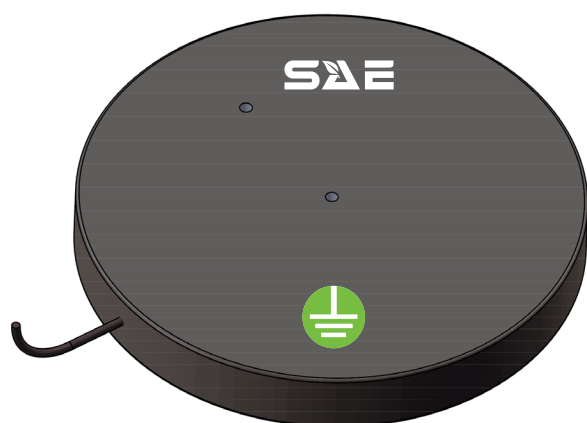
Side View

Installation is reversible - can  
be mounted from either side
