# PRODUCT SPECIFICATION RESOURCE

Contains specifications and test reports for  
ConduDisc Flex manufactured by SAE Inc.

ConduDisc Flex is designed to be fully compliant with  
the NESC, CSA Standard C22.2, ESA On. Reg 22/04.

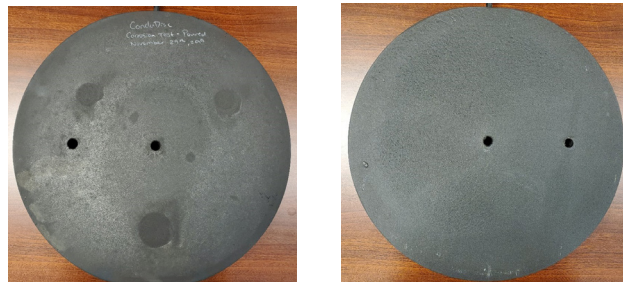
Figure 6: ConduDisc, Prior to the Experiment

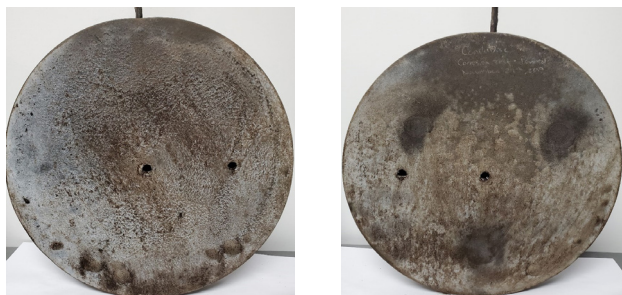
Figure 14: ConduDisc, After Experiment

In comparison, the ConduDisc, a galvanized steel plate encased in a conductive polymeric surround, experienced no loss of mass during the one-year study. The low permeability of the ConduDisc surround material protected the encased galvanized steel plate from exposure to the moisture and salt in the soil, thus preventing any corrosion from occurring.

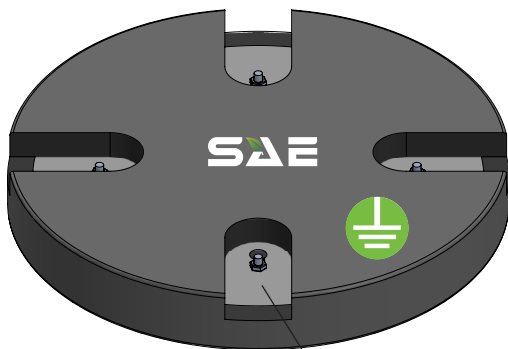
## ConduDisc Flex Product Specifications | 4 SLOT

Connect #6 - 4/0  
wire of choice
