# PRODUCT SPECIFICATION RESOURCE

Contains specifications and test reports for  
ConduDisc Elite manufactured by SAE Inc.

ConduDisc Elite is designed to be fully compliant with the NESC, CSA  
Standard C22.2, ESA On. Reg 22/04.

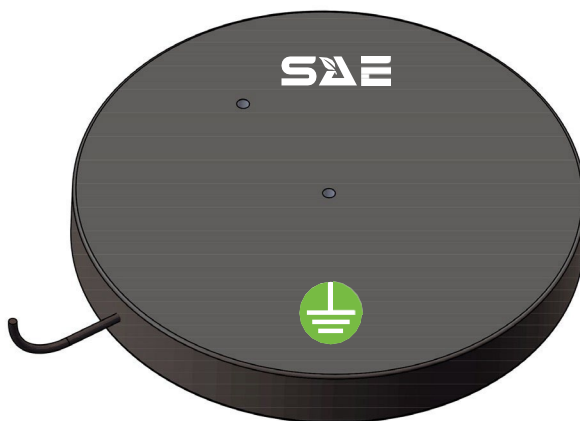
Detail

ConduWire is a conductive, flexible, easy to strip jacket that prevents copper corrosion while maintaining the fundamental electrical conductivity to ground.

Choice of #6 AWG - 4/0 wire available upon ordering.

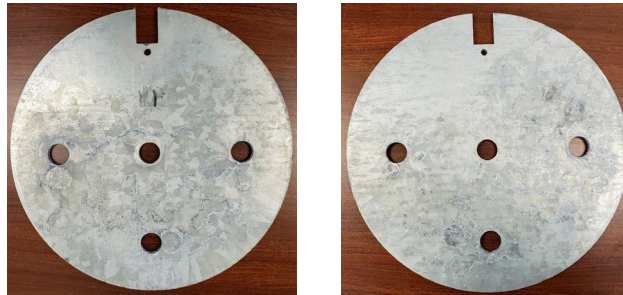
Figure 4: Galvanized Steel Grounding Plate, Prior to the Experiment

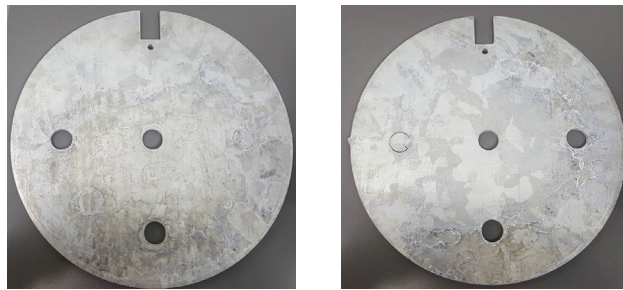
Figure 5: Galvanized Steel Grounding Plate to be Encapsulated in ConduDisc Surround Material, Prior to the Experiment

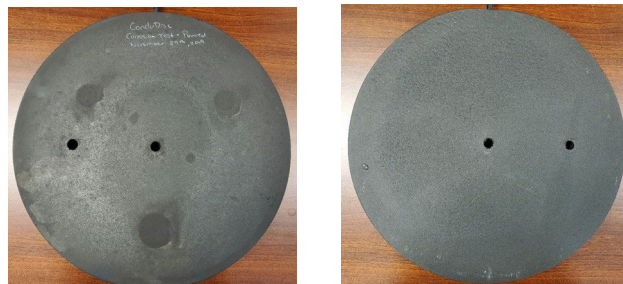
Figure 6: ConduDisc, Prior to the Experiment

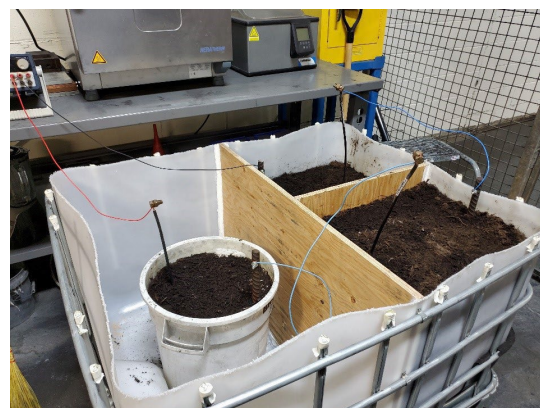
Figure 7: Test Setup

In order to compare the longevity of various utility pole grounding plates, an experiment was conducted which measured the corrosion rate of the three different utility pole grounding plates, a Blackburn GP-100 Copper Grounding Plate, a Galvanized Steel Grounding Plate, and a ConduDisc, when buried in damp, salty soil and exposed to a constant low current of 10 milliamps for one year.

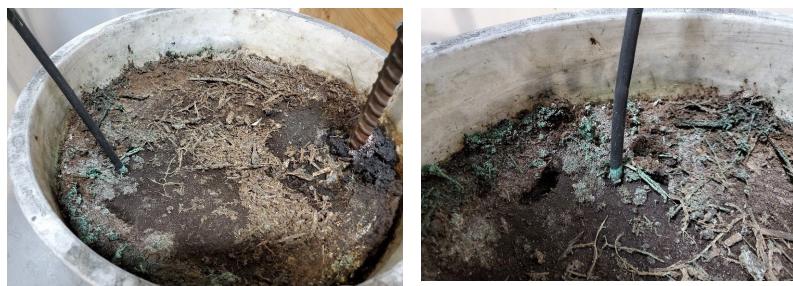
Figure 10: Copper Salt Visible on Top of the Soil in the Blackburn GP-100 Copper Grounding Plate Pail at the Completion of the Experiment

- 3.2 After one year the experiment was completed and the samples were removed from the soil for analysis. The samples were cleaned and weighed using an electronic balance. As shown in Table 2 and Figures 10, 11, and 12 the Blackburn GP-100 Copper Grounding Plate experienced significant corrosion during the course of the experiment and only 25.6% of the grounding plate remained after being exposed to 10 mA for one year. Additionally shown in Table 2 and Figure 13 the galvanized steel grounding plate corroded during the course of the experiment, losing 1.25% of its mass after being exposed to 10 mA for one year and visibly oxidizing on over half of the exposed surface. In contrast, as shown in Table 2 and Figures 14 and 15, the galvanized steel plate encased in ConduDisc surround material did not visibly oxidize and experienced no change in mass after being exposed to 10 mA for one year. The small gain in mass can be attributed to the small amount of ConduDisc surround material that could not be removed from the galvanized steel plate prior to weighing.

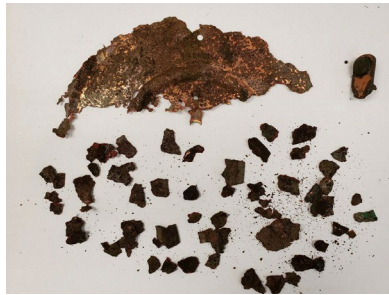
Figure 12: Blackburn GP-100 Copper Grounding Plate with Corroded Pieces Remaining in Soil, After Experiment

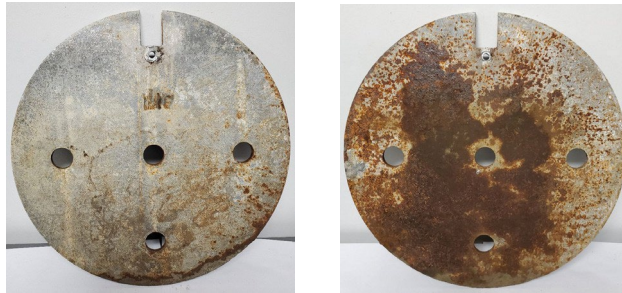
Figure 13: Galvanized Steel Grounding Plate, After Experiment

The Galvanized Steel Grounding Plate experienced a loss in mass of 1.25% during the one-year study. Additionally, there was a large amount of visible oxidation of the surface of the Galvanized Steel Grounding Plate, the zinc coating on approximately half of the exposed surface had corroded.

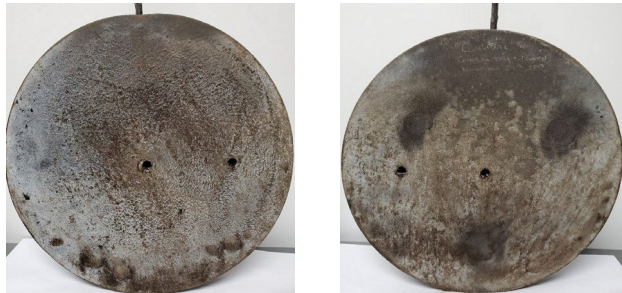
Figure 14: ConduDisc, After Experiment

In comparison, the ConduDisc, a galvanized steel plate encased in a conductive polymeric surround, experienced no loss of mass during the one-year study. The low permeability of the ConduDisc surround material protected the encased galvanized steel plate from exposure to the moisture and salt in the soil, thus preventing any corrosion from occurring.

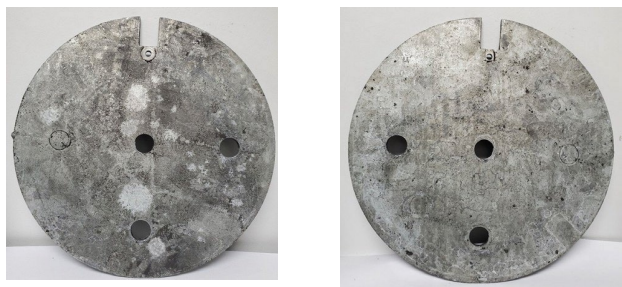
Figure 15: Galvanized Steel Plate that was Encased in ConduDisc Surround, After Experiment
